Improvement of aircraft mechanical damage inspection with advanced 3D imaging technologies

CREAFORM

2. Case study: in-flight damage on Qantas Airbus 380

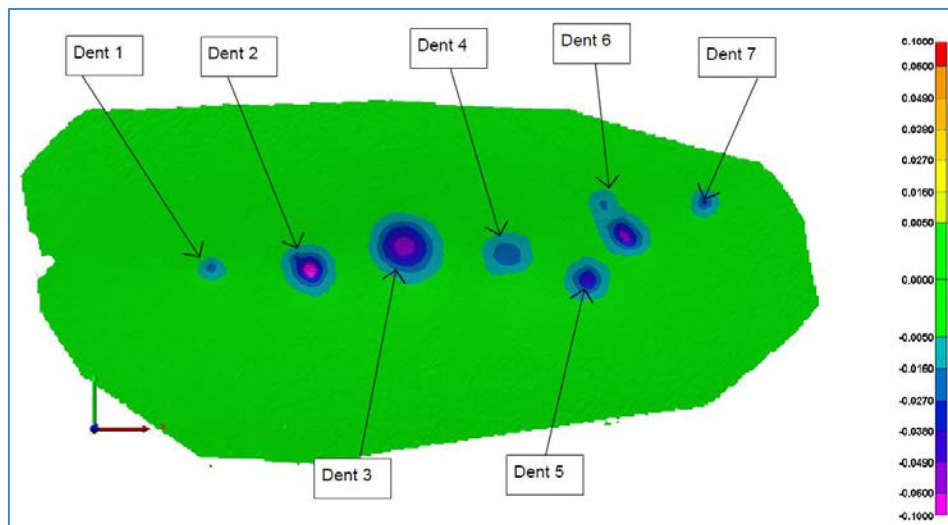
Figure 4: 3D colormap of 7 impacts on fuselage

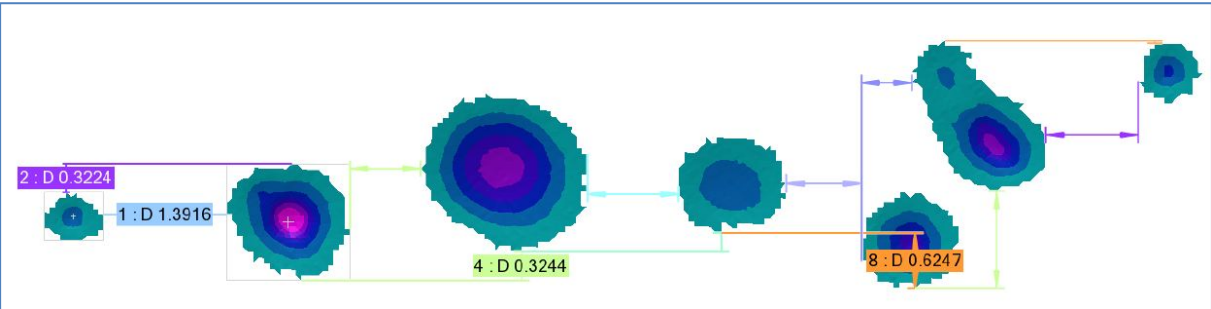
In the case where multiple dents are found in the same area, interaction between dents must be verified by measuring the minimum distance between dents.

Figure 5: Minimum distance measured between dents to validate interaction

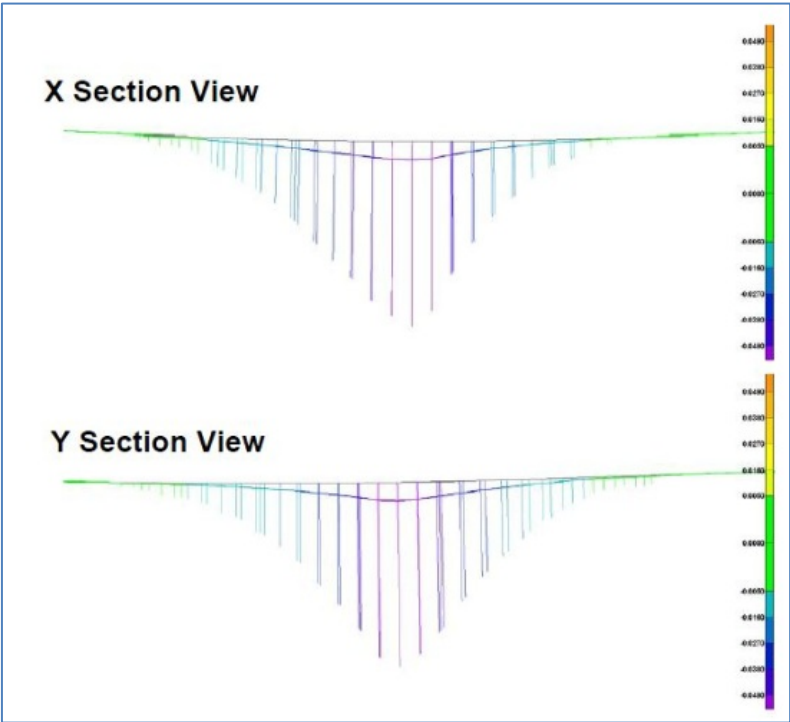
Figure 6: 2D cross section on one dent

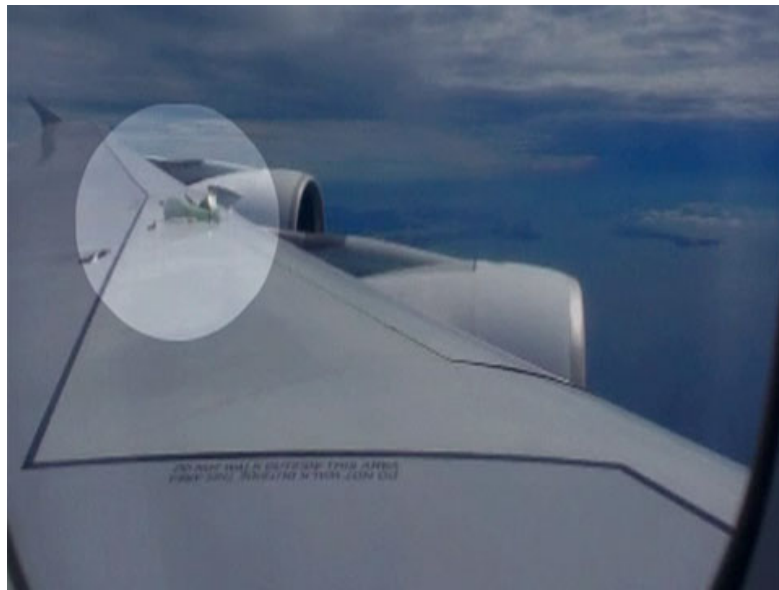
One of the blade on engine #2 broke and damaged the protection carter and left wing. The objective for this inspection is to quantify wing damage and compare to traditional methods. In this case, a combination of 3D laser scanning and photogrammetry was used to properly characterize damage and secondary effects on the wing structure.

Figure 7: Picture of wing damage during flight

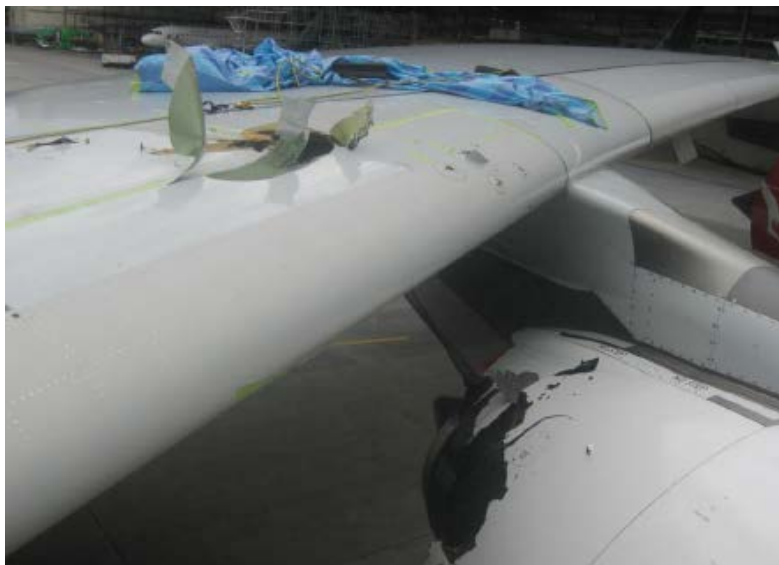
Figure 8: Wing damage caused by engine failure

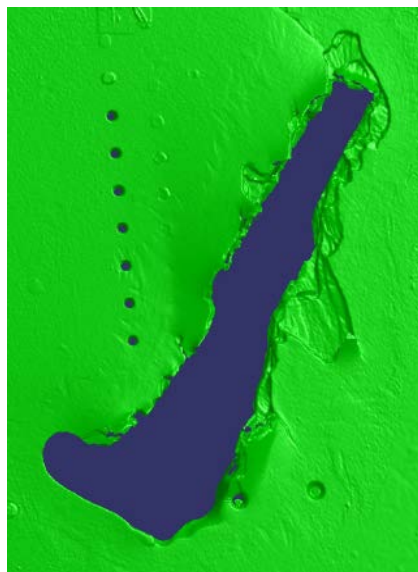
Figure 10: 3D scan of wing damage

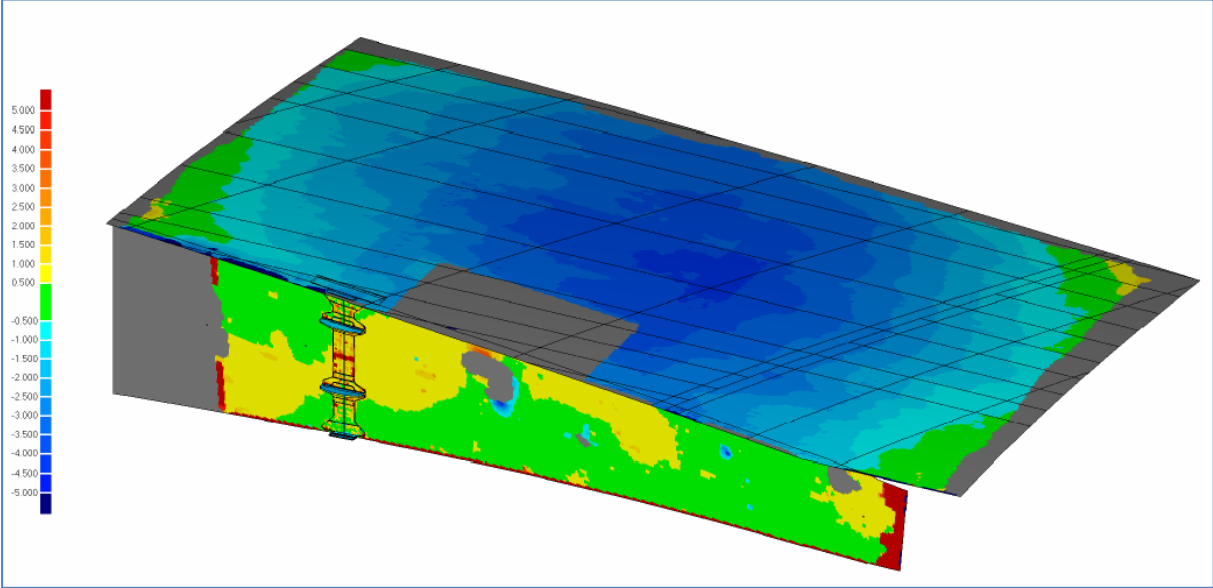
The client wanted to assess the wing deformation caused by the impact. From the 3D scan file of the wing section, the local deformation was measured and represented in picture 11 in a blue scale color.

Figure 11: Characterization of wing deformation around the defect

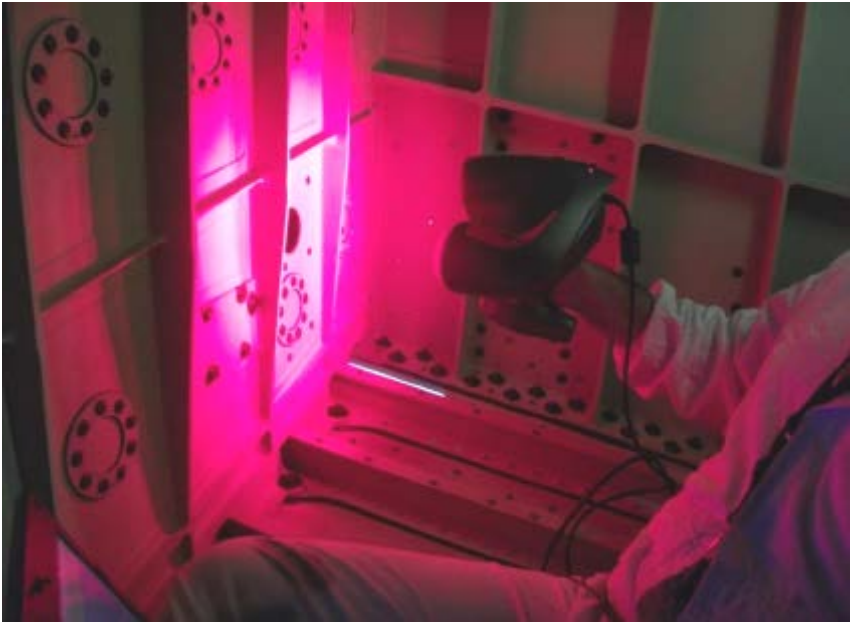
The fuel tank structure inside the wing was suspected to be deformed following the impact and had to be inspected. The same scanner and methodology was used to obtain a 3D scan of the fuel tank which was then compared to a CAD file representing the nominal shape. Figure 12 shows the fuel tank deformation caused by the impact on the wing.

Figure 12: Scan of fuel tank inside the wing to measure deformations

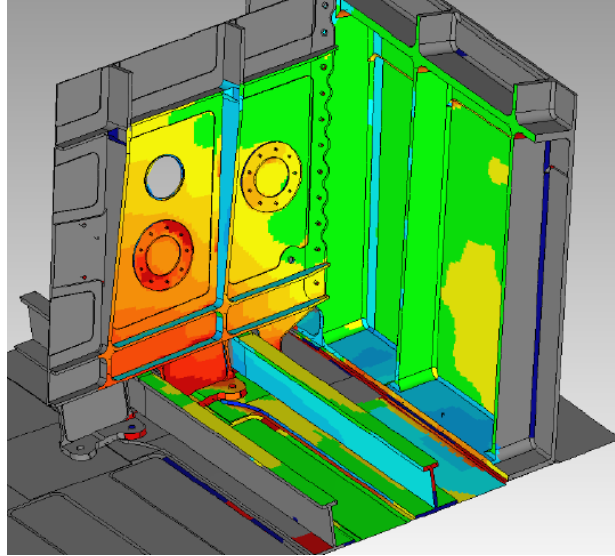
Figure 13: 3D color map of deviations on fuel tank caused by the impact
