Improvement of aircraft mechanical damage inspection with advanced 3D imaging technologies

CREAFORM

2. Case study: in-flight damage on Qantas Airbus 380

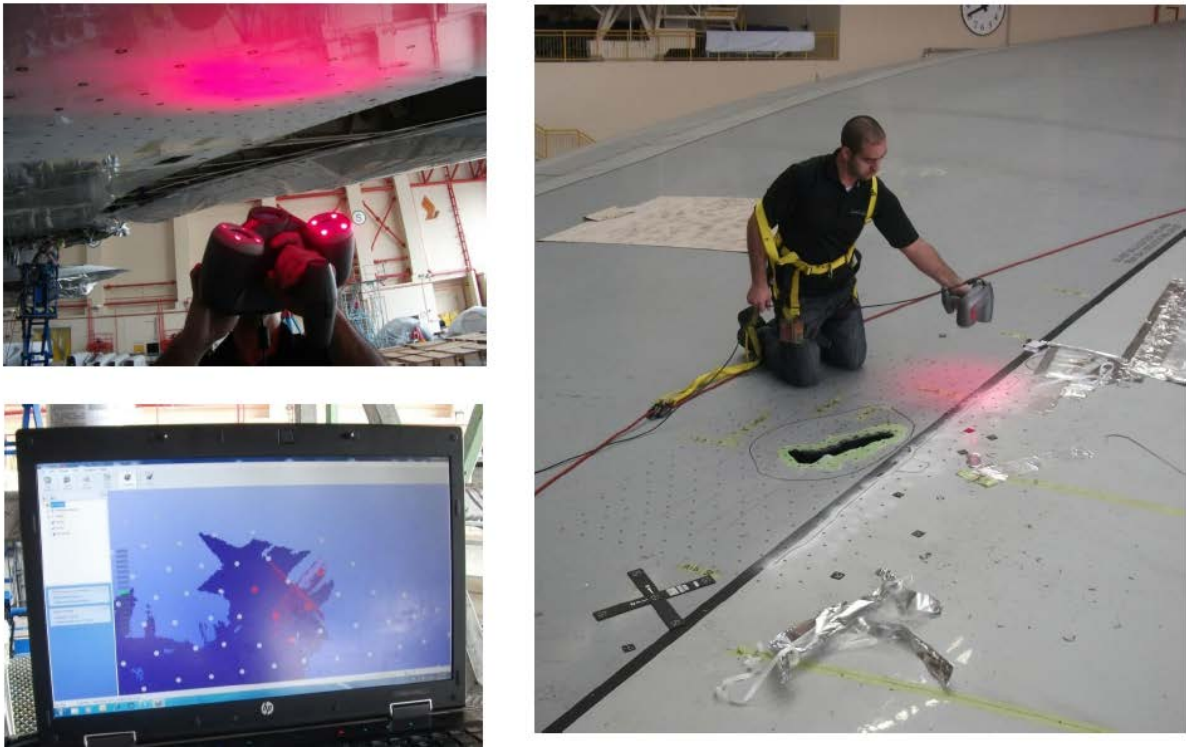
Figure 9: Inspector scanning the damaged wing section with the laser scanner

One of the blade on engine #2 broke and damaged the protection carter and left wing. The objective for this inspection is to quantify wing damage and compare to traditional methods. In this case, a combination of 3D laser scanning and photogrammetry was used to properly characterize damage and secondary effects on the wing structure.

The first step was to ensure very high precision for the 3D laser inspection on the wing so photogrammetry was used to increase the positioning model accuracy. The MAXshot manufactured by Creaform is used as a complement to the Handyscan3D to take picture of the positioning model with scale bars and therefore bring down the accuracy to $0.020\text{mm} + 0.025\text{mm}$ per meter of scan. Once the referencing model is acquired, the 3D laser scan is then performed around the damaged area to generate a 3D scan file. This procedure is only required for the scan of large objects such as an Airbus 380 wing.
